RECOVER ROOF - CASALI - TYPICAL INTERNAL GUTTER

RECOVER ROOF - JM TPO - TYPICAL INTERNAL GUTTER

DRAWING REF:
RC-003

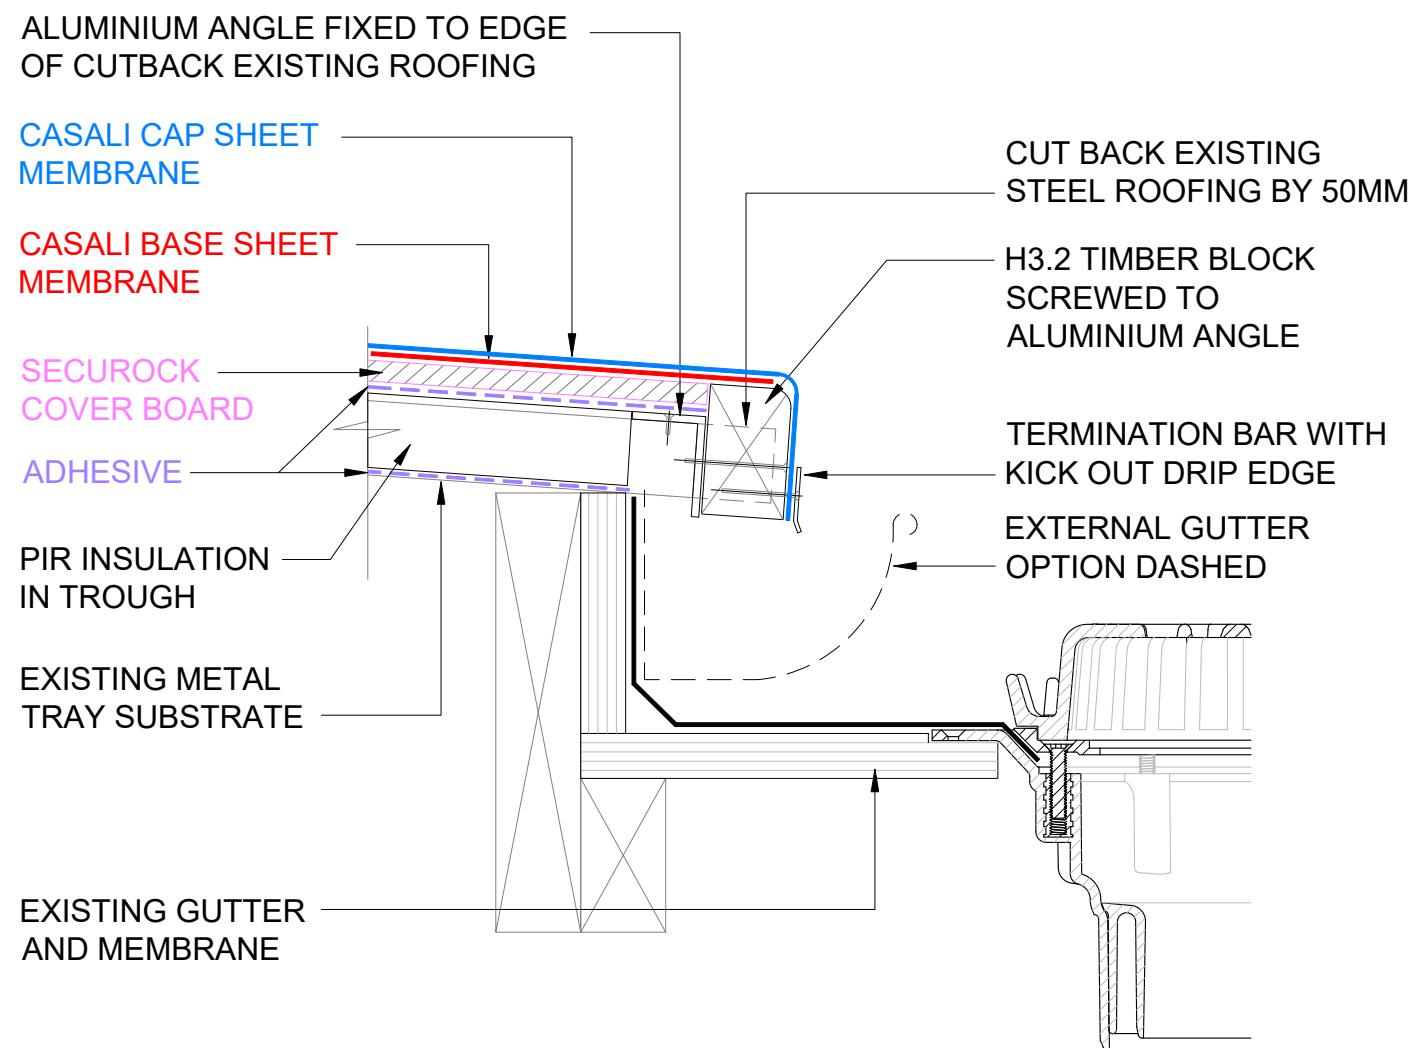
1

EXTERNAL GUTTER OPTION DASHED

NOTE:
ASSESSMENT OF THE EXISTING GUTTER MEMBRANE CONDITION SHOULD BE UNDERTAKEN AND DISCUSSED WITH YOUR ALLCO REPRESENTATIVE

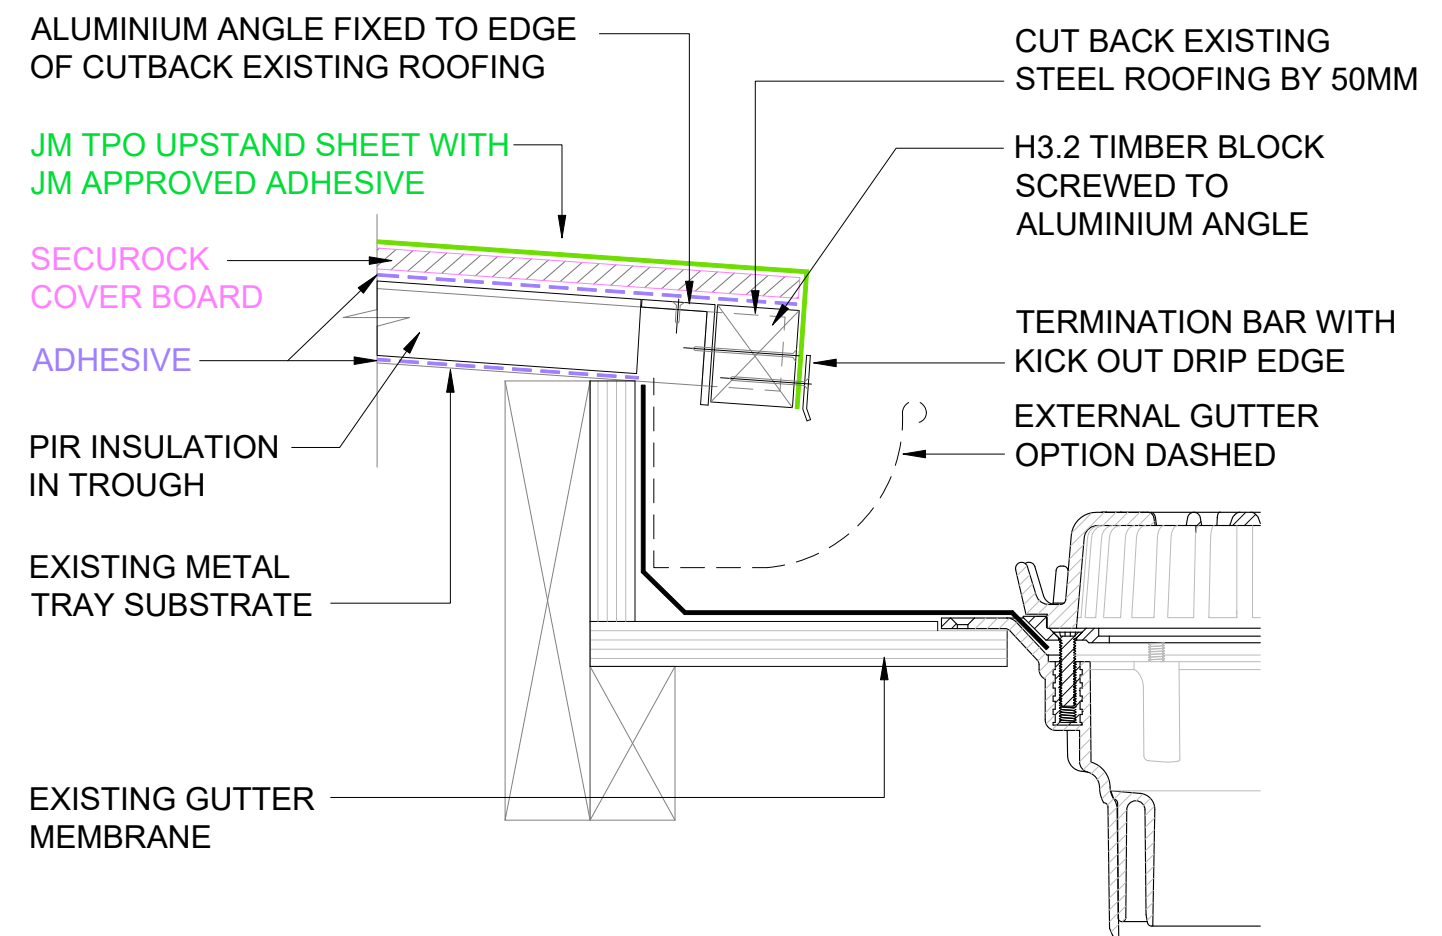
2

EXTERNAL GUTTER OPTION DASHED
