## RECOVER ROOF - CASALI - TYPICAL INTERNAL GUTTER

## RECOVER ROOF - JM TPO - TYPICAL INTERNAL GUTTER

DRAWING REF:  
RC-004

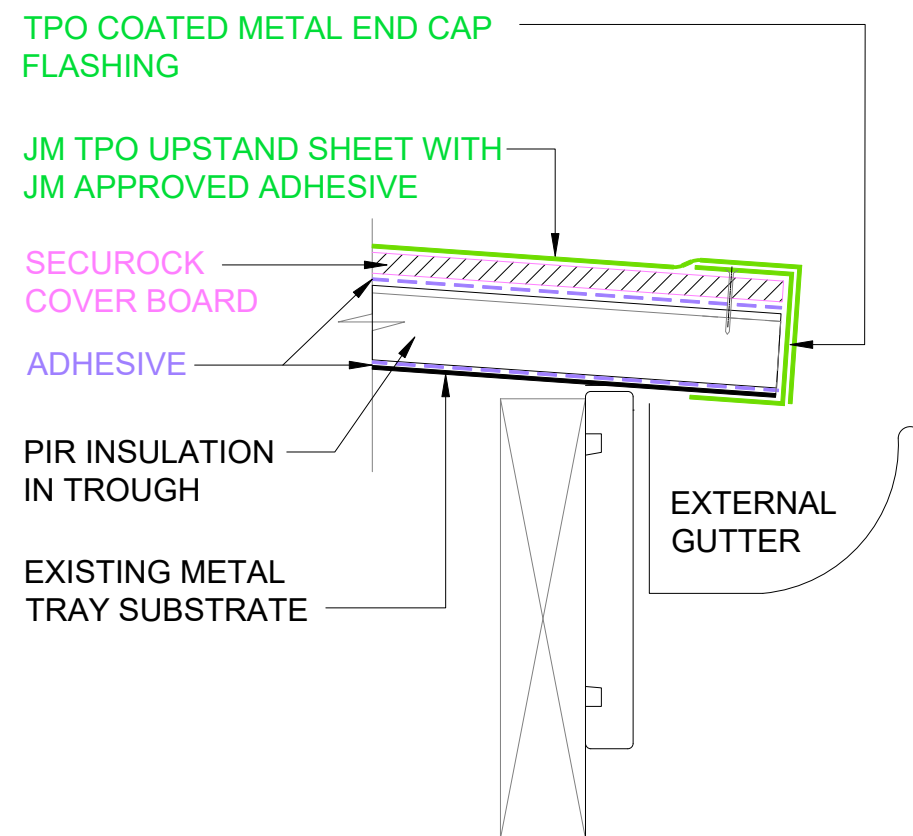
1

EXTERNAL GUTTER OPTION DASHED

NOTE:  
ASSESSMENT OF THE EXISTING  
GUTTER MEMBRANE CONDITION  
SHOULD BE UNDERTAKEN AND  
DISCUSSED WITH YOUR ALLCO  
REPRESENTATIVE
